# BUILT IN A SAND TRAP

Long Island designer/builder Steve Kenny describes a catastrophic project failure and the lengths required to regain a firm footing

By Steve Kenny

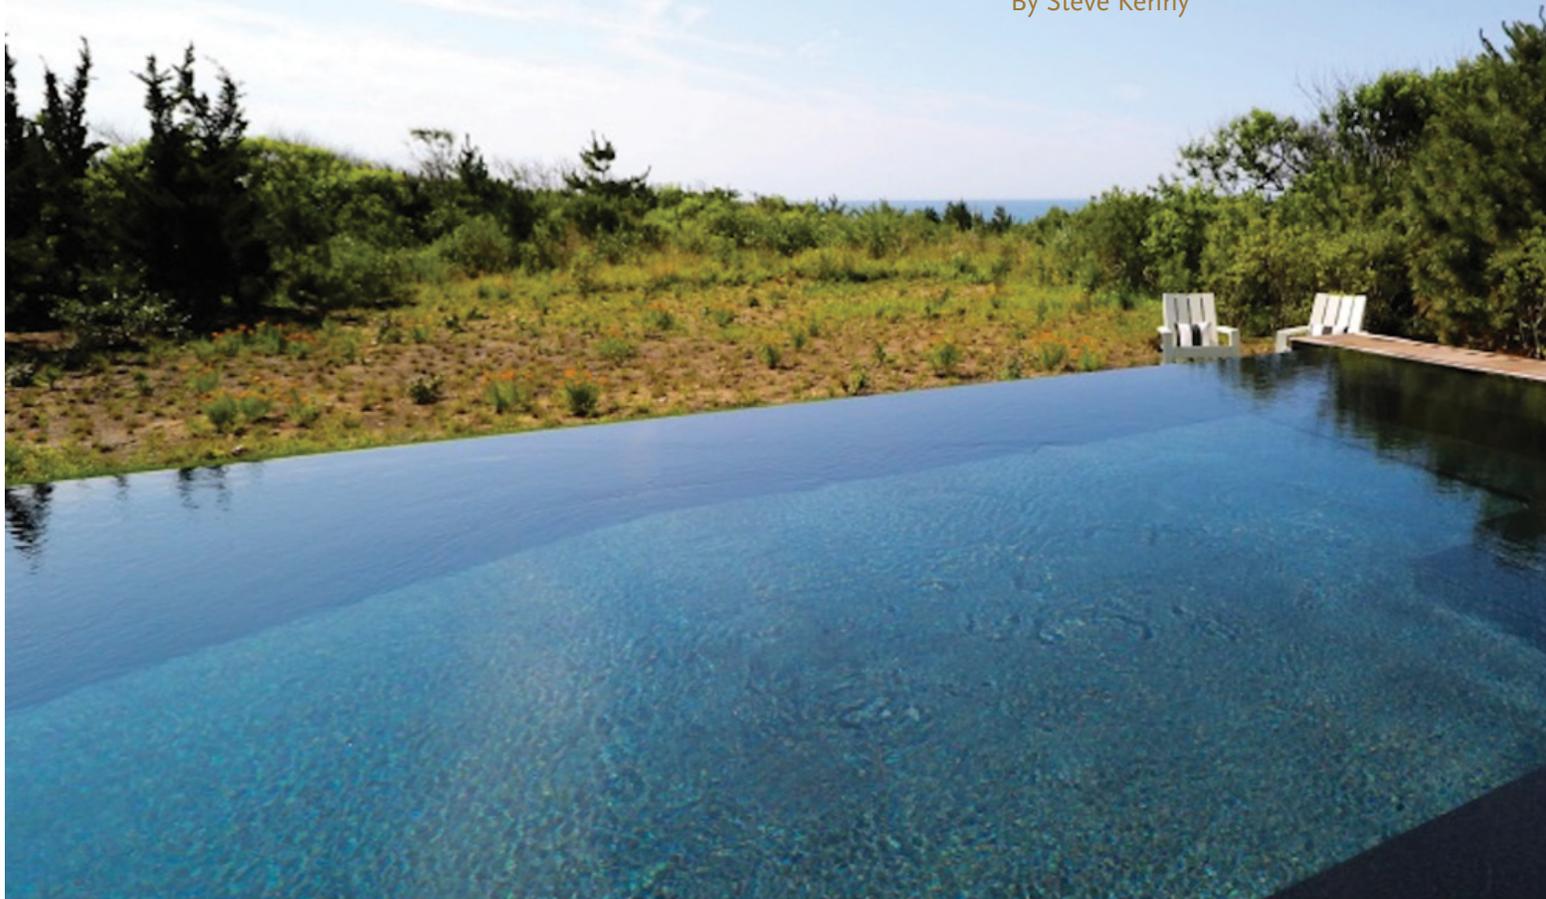
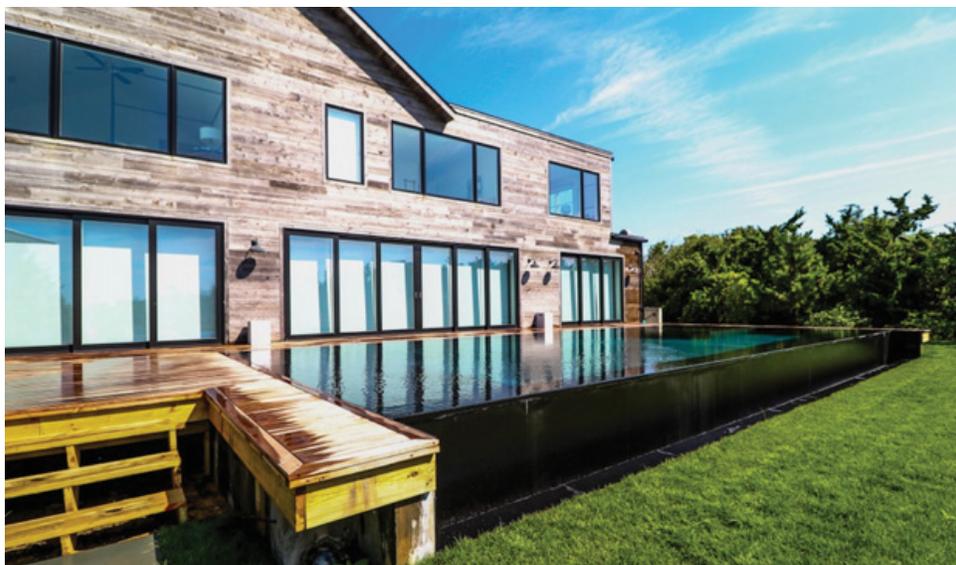
This beautiful oceanside setting came with geological conditions and environmental easements that required an ingeniously creative structural solution.

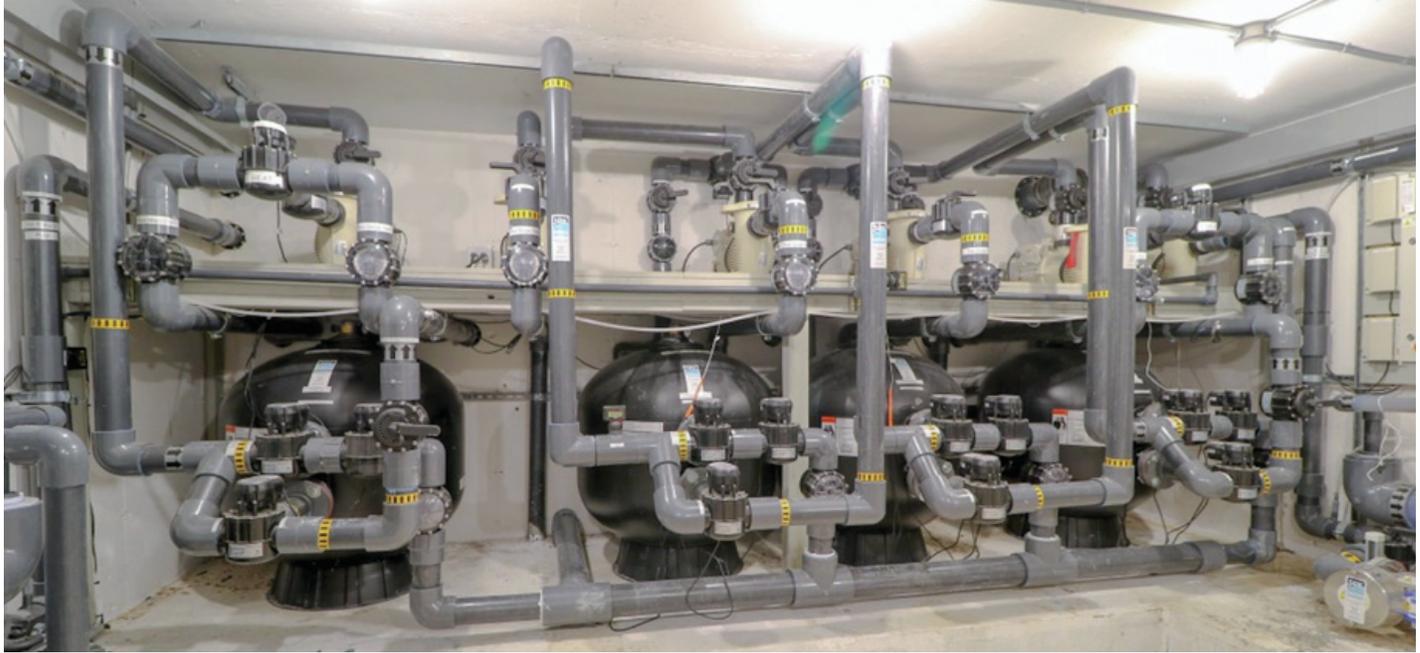
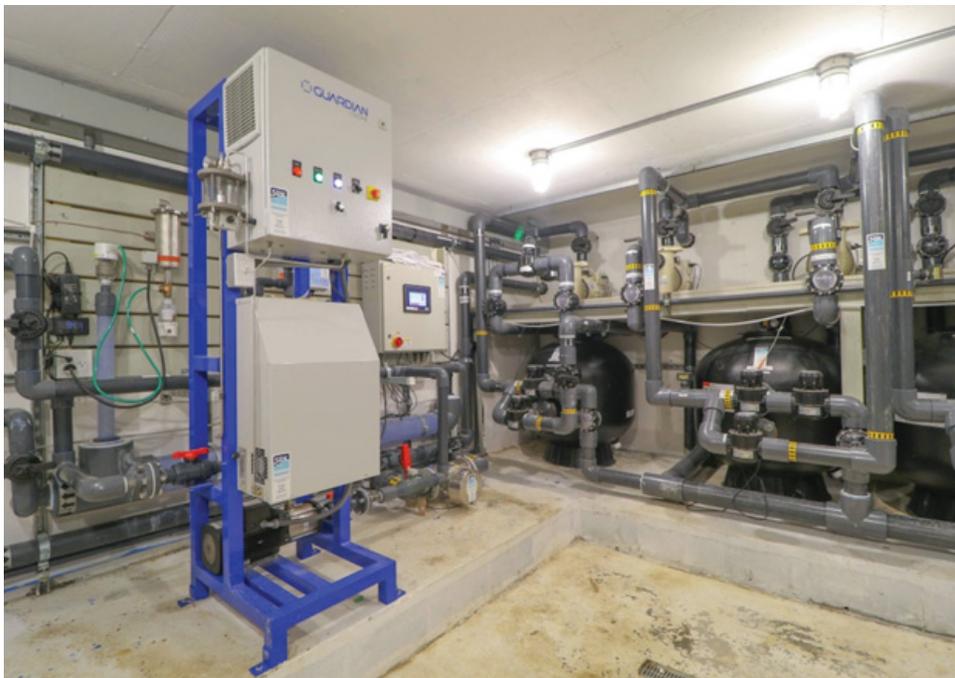
The equipment room located beneath the deep end serves the dual purpose of housing the equipment in a comfortable and accessible space while also serving as the pool's foundation in sandy soil conditions.

That set of issues set the stage for a truly ingenious solution: We decided to locate the equipment underneath the deep end of the pool in a large reinforced vault that also serves as a massive footing. It’s a beefy structure that

we started referring to as “the bomb shelter.” It’s 20-by-20 feet in two separate rooms with a 2-foot thick floor slab, 18-inch walls and a 2-foot slab roof that distributes the weight of the pool. The pool itself is equally hefty with 18-inch walls, all needed to exist comfortably in the constantly shifting ground.

The equipment room is accessed by a flight of stairs that descends beneath the narrow deck between the pool and the back of the house. With its 7-foot ceilings, ventilation and easy access, the equipment rooms are comfortable and even welcoming.

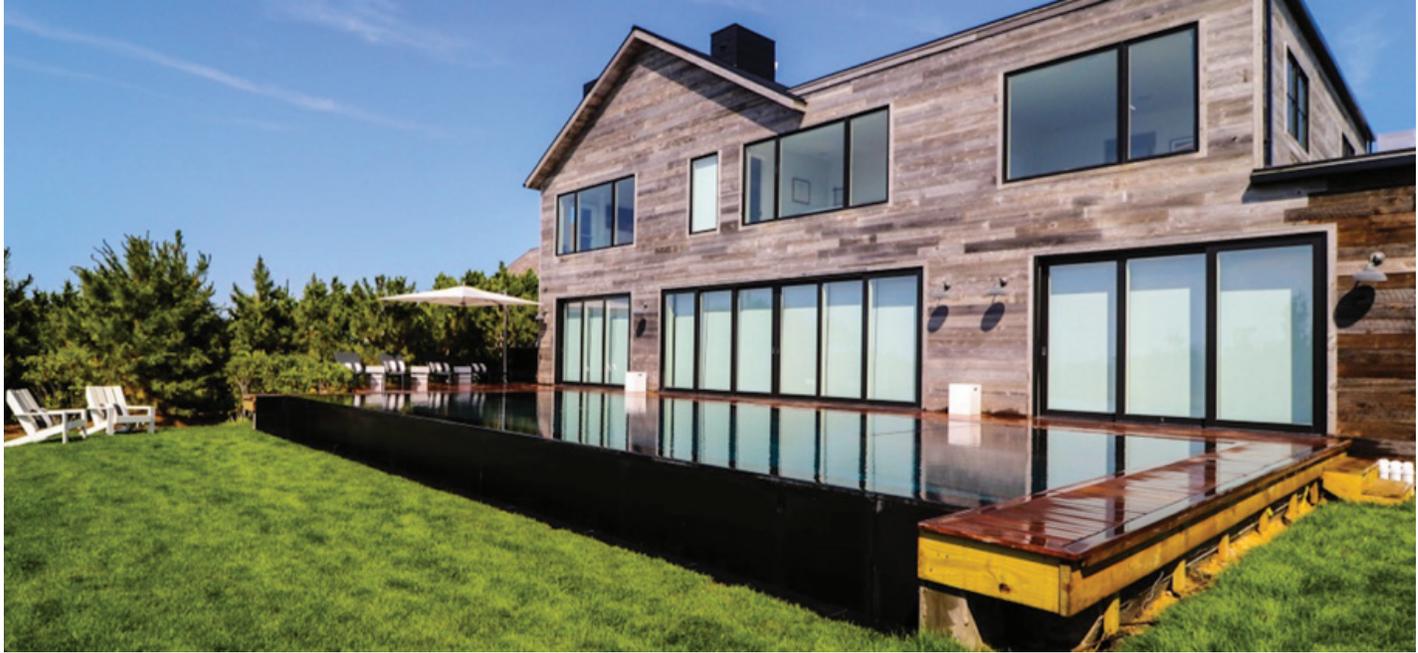
So that's what we did. The new pool is 18-by-42 feet with an 8-by-8-foot inset attached spa. It has a perimeter overflow Lautner edge detail on three sides and a vanishing edge down the length of the pool on the other. It has a

total volume of about 25,000 gallons with the surge capacity handled in two surge tanks.
